Philips Pressurised steam generator GC8330/02 180 g steam boost 5 bar SteamGlide with Detachable water tank
GC8330/02

Service information

Reference no.: SDA_97593

1W and 0.5W Power Board and Control Board

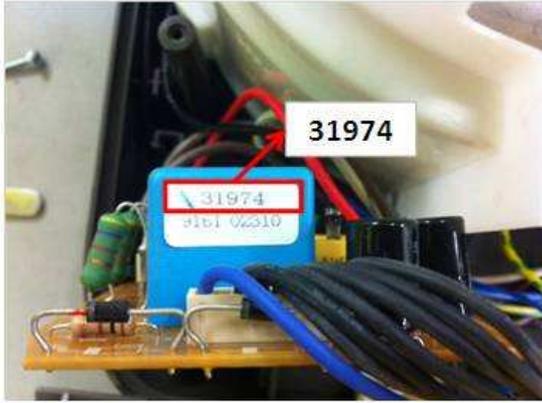
<p>31974</p> <p>31974 3161 02310</p>

Power Board	Control Board
OLD

CTN	Return set GC82xx, GC83xx	Repair option
GC82xx, GC83xx	**If Control Board PCBA Assy (Pos 44) is 4239 021 56871 or 4239 021 56881 or 4239 021 31969	Option 1* Pos 43: Replace Power Board PCBA Assy, 4239 021 31970 Option 2 (Must replace both Power Board and Control Board) Pos 43: Replace Power Board PCBA Assy, 4239 021 73241 and Pos 44: Replace Control Board PCBA Assy, 4239 021 73231
	If Control Board PCBA Assy (Pos 44) is 4239 021 73231	Option 3 Pos 43: Replace Power Board PCBA Assy, 4239 021 73241

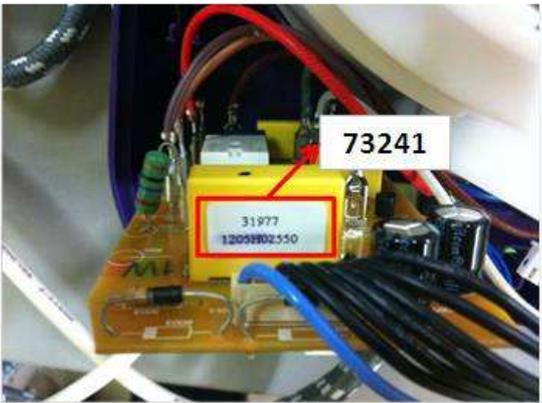
<p>73241</p> <p>31977 12091902550</p>

Power Board PCB Assy upgraded from 1W to 0.5W standby power..
