Published by:  
Service Department Portable Audio

## LINE OF BUSINESS PORTABLE AUDIO

# SERVICE NEWSLETTER

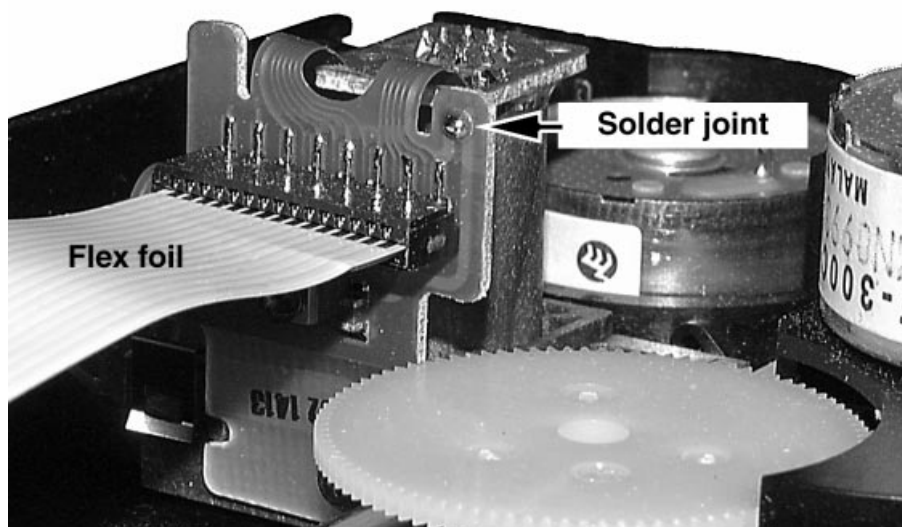
**INFORMATION** : The laser diode of the VAM2201 is protected against ESD by a solder joint which shortcircuits the laser diode to ground.  
For proper functionality of the CD drive this solder joint must be removed **after** connecting the flex foil to the drive.

**REMARKS** : An addendum sheet will be packed to the CD drive, pointing out the above modification.

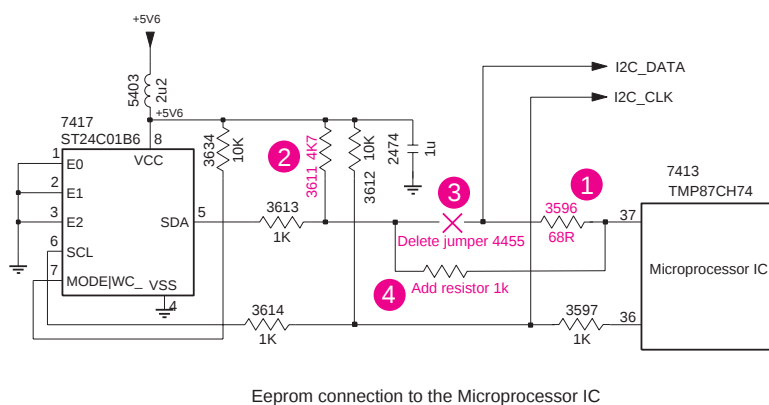
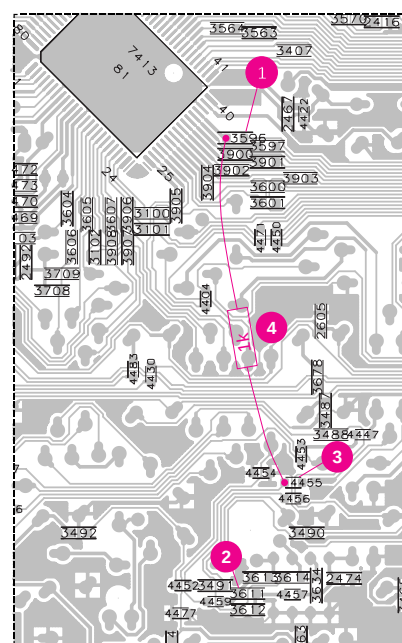
Portion of the Front board (copper side view)

- Loss of Tuner preset stations or tuning grid returns to 9kHz condition
- When changing source to Tuner the set stalls for a few seconds and may or may not switch to Tuner mode
- CD carousel rotates or the CD tray moves outwards
- Tape deck motors start to run or relay starts activation and the deck starts engaging and disengaging
- During this strange behaviour condition the set does not go into demo mode

: The problem is caused by corrupted data being written into the EEPROM IC 7417 via the I2C\_DATA line. The data corruption can be verified and cleared by performing an “EEPROM Format Test” in the Service Test Program.

The problem can be solved by the following hardware modification on the front board:

1. Ensure (change if necessary) that resistor 3596 is 68Ω (4822 117 12521)
2. Change resistor 3611 to 4.7kΩ (4822 051 20472)
3. Remove SMD jumper 4455
4. Add resistor 1kΩ (4822 050 11002) with insulated leads between pin 37 of microprocessor IC 7413 and junction of resistors 3611 and 3613 (left solder pad of jumper 4455)
5. Clear the corrupted data in the EEPROM as follows:
  - a) Enter the Service Test Program by holding the **PLAY ►** and **AUX** button depressed while switching on the mains supply
  - b) Perform an “EEPROM Format Test” by pressing the **SEARCH ◀◀** button to reset the EEPROM to default data
  - c) Exit the Service Test Program by disconnecting the mains supply

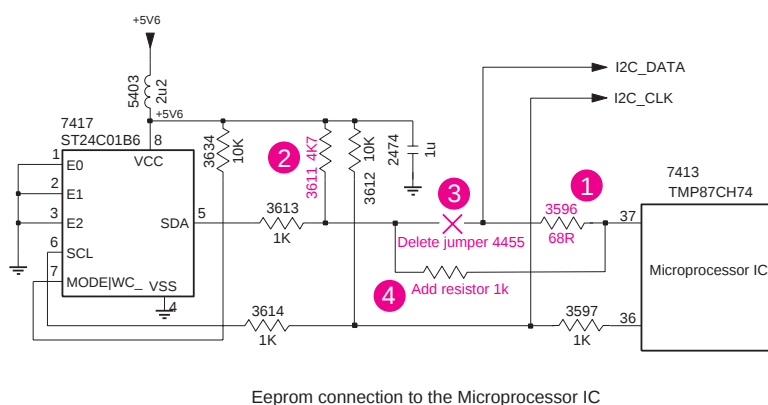
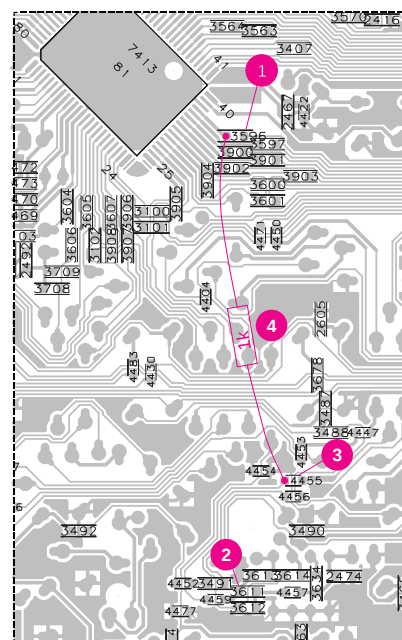
Portion of the Front board (copper side view)

- Loss of Tuner preset stations or tuning grid returns to 9kHz condition
- When changing source to Tuner the set stalls for a few seconds and may or may not switch to Tuner mode
- CD carousel rotates or the CD tray moves outwards
- Tape deck motors start to run or relay starts activation and the deck starts engaging and disengaging
- During this strange behaviour condition the set does not go into demo mode

CURE : The problem is caused by corrupted data being written into the EEPROM IC 7417 via the I2C\_DATA line. The data corruption can be verified and cleared by performing an “EEPROM Format Test” in the Service Test Program.

The problem can be solved by the following hardware modification on the front board:

1. Ensure (change if necessary) that resistor 3596 is 68Ω (4822 117 12521)
2. Change resistor 3611 to 4.7kΩ (4822 051 20472)
3. Remove SMD jumper 4455
4. Add resistor 1kΩ (4822 050 11002) with insulated leads between pin 37 of microprocessor IC 7413 and junction of resistors 3611 and 3613 (left solder pad of jumper 4455)

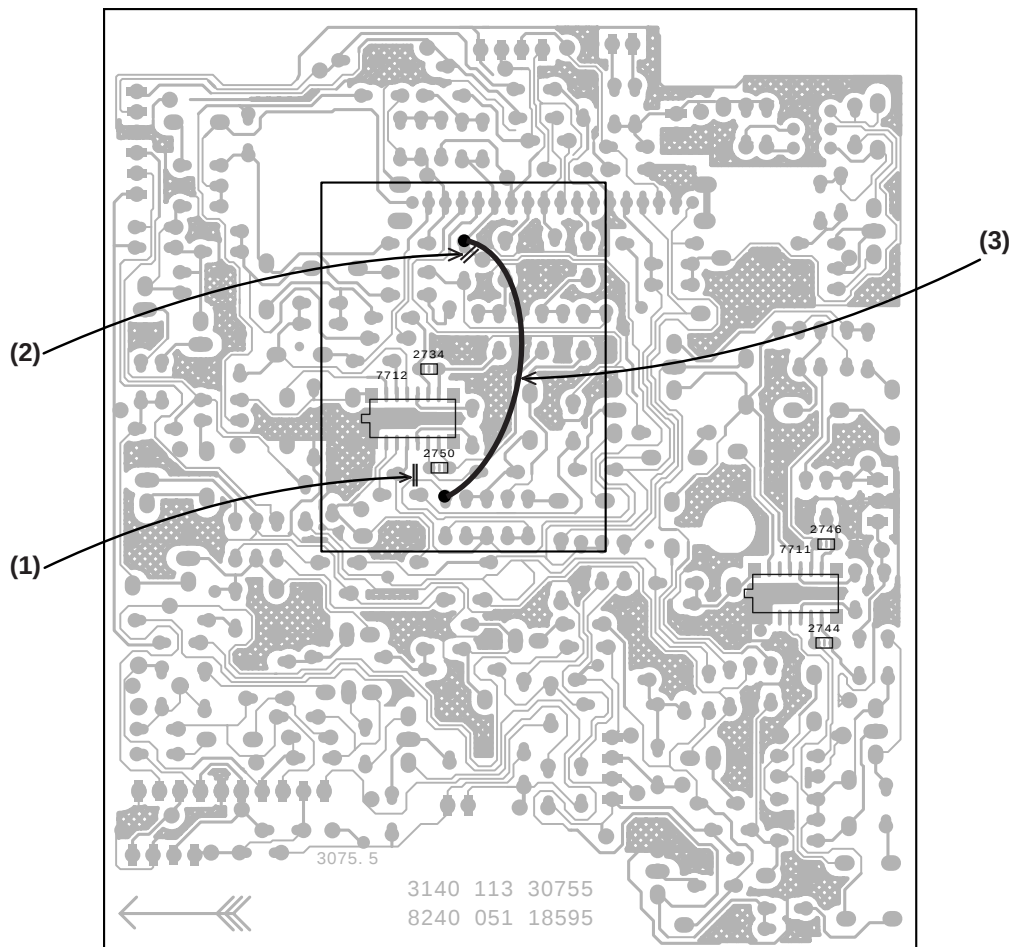
Recorder Board - Layout Diagram  
(PCB code : 3140 113 30755)

SYMPTOM : **IRIS CODE C 1 4 X**  
Abnormal noise is audible in TAPE mode.

CURE : The signal paths on the Recorder board are too close.  
Solution is to cut 2 copper tracks on the printed board and to connect resistor 3729 and capacitor 2736 with a wire (for details see diagram below).

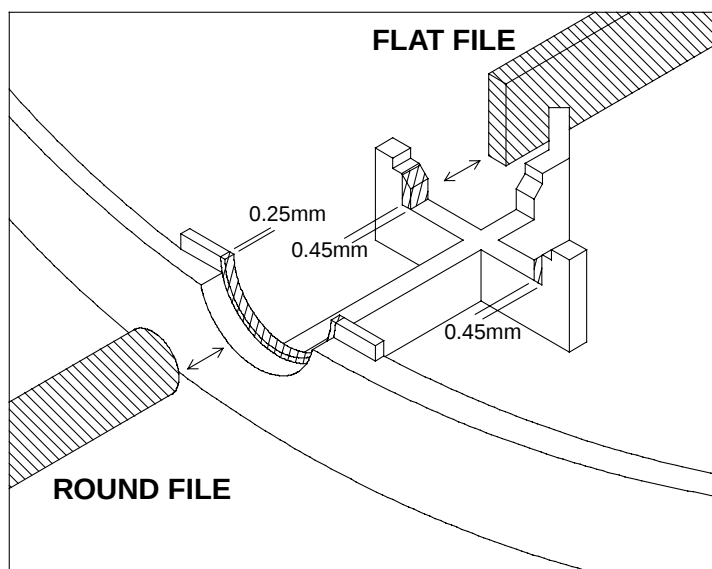
**INFORMATION** : In course of production, the PCB Assembly was changed to PB2 (for details please refer to Service Manual 4822 725 26021).  
In the PB2 assembly a smaller headphone jack was used and thus the hole for h/p jack on the cabinet was also made smaller.  
The cabinet (4822 449 80201) of the sets produced in earlier stage is no longer available and the new cabinet (4822 449 80266) with smaller jack hole will be delivered as substitute.

As a service solution, for repairing sets with bigger headphone jack, we suggest to enlarge the hole by use of files (see drawing below).

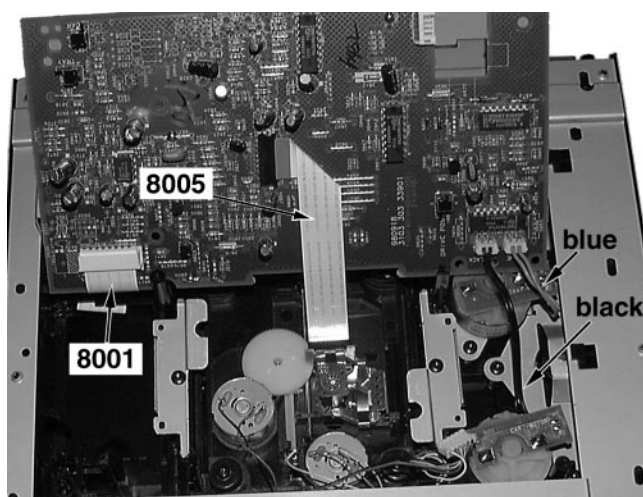
fig.1 – location of flex-foils

**INFORMATION** : Correction to the Service Manual, Partslist  
The following flex-foils and flex-foil-connector were missing and have been added to the partlist of the 3CDC-99 Module (chapter 10).

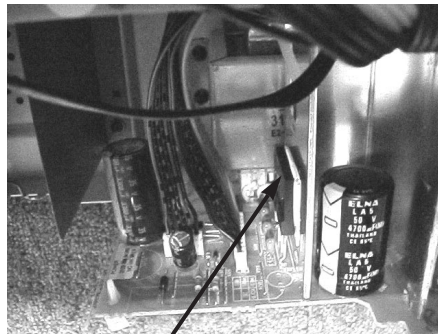
**INFORMATION** : During production weeks 9921 to 9925, some sets have been produced without the Clip-Rectifier, that enhances the heat transfer between Rectifier and Heatsink. Below pictures show the Power Supply board with and without the Clip-Rectifier.

clip-rectifier missing

**REMARKS** : All sets from production weeks 9921 to 9925 that come in for repair must be checked – Missing clips have to be added as preventive action. The service code reads 4822 492 11068.

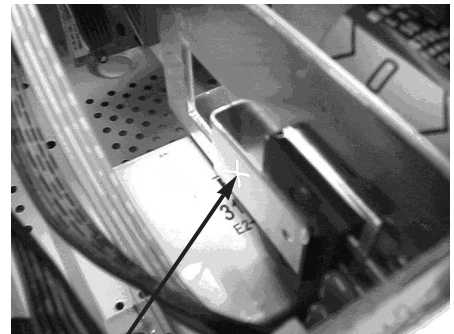
clip-rectifier in position

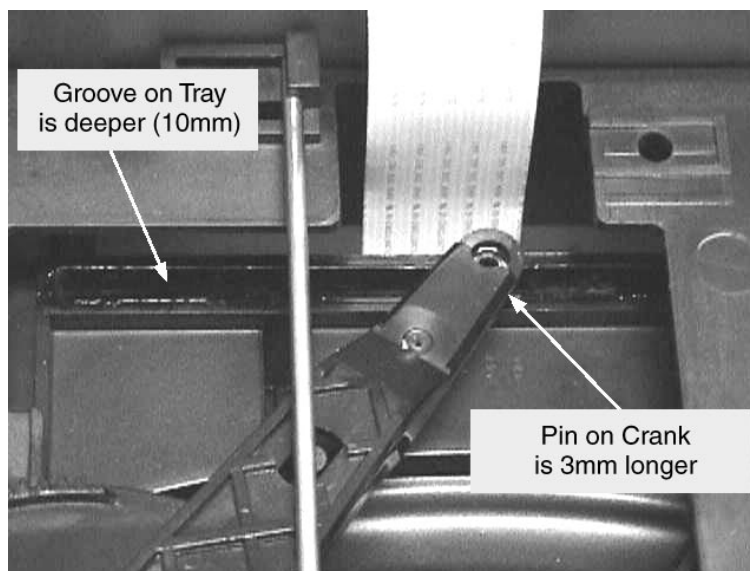
From production wk9835 onwards, the Tray and Crank have been modified. The groove on the tray is now deeper and likewise the pin on the Crank is 3mm longer.

Due to this change the new Crank does not fit into the old Tray anymore. But it is still possible to use the old Crank on the new Tray.

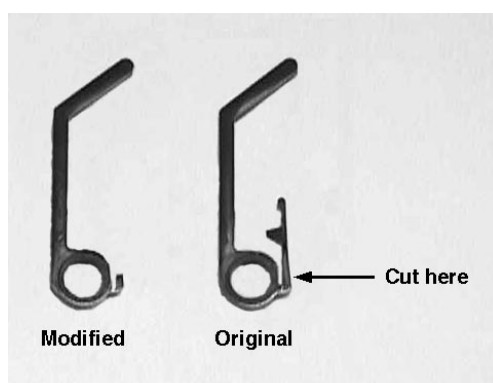
When CD tray was activated to open, the tray would move out and immediately go in again or stop at half way.  
When the CD tray is in motion the inside arm of the switch bracket (pos 123) hits the micro switch earlier than the main lever.

**CURE** : The problem can be solved by cutting a section of the inside arm of the switch bracket as indicated below:
