BUSINESS CREATION UNIT AUDIO

SERVICE NEWSLETTER

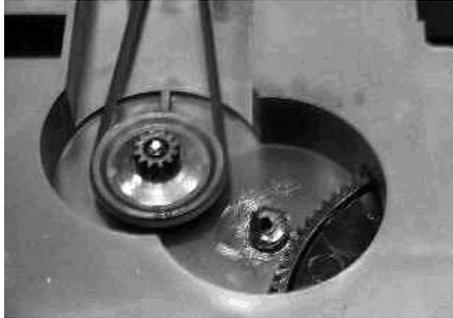
SYMPTOM : **IRIS CODE 1 1 6 X**

CDC Tray does not open, the spindle for the Gearwheel (pos 95) is broken (see picture below).

CURE : For integral cost reasons it is advised to exchange the complete set.

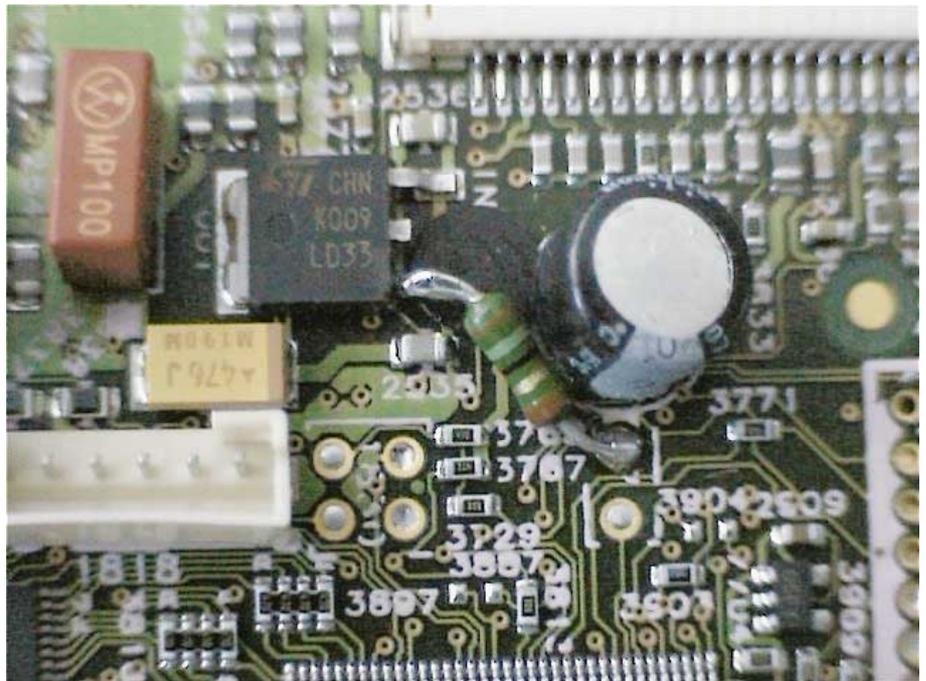
Clock jitter in DASP-IC item 7701 on CDR Mainboard can result in hang-up of the microprocessor. After Power off, Power on the set will normally start but the phenomenon might return again.

See part of the main board (top side view) for location of the resistor.

CURE : To solve this problem in running production and as service solution, the power supply of D3V3 has been improved by adding a resistor of 27Ω (CRB 1/6W A PM5 and codenumber 4822 116 52188) between "disconnected" pin 1 of item 7535 and ground (hole 2 of item 1701).

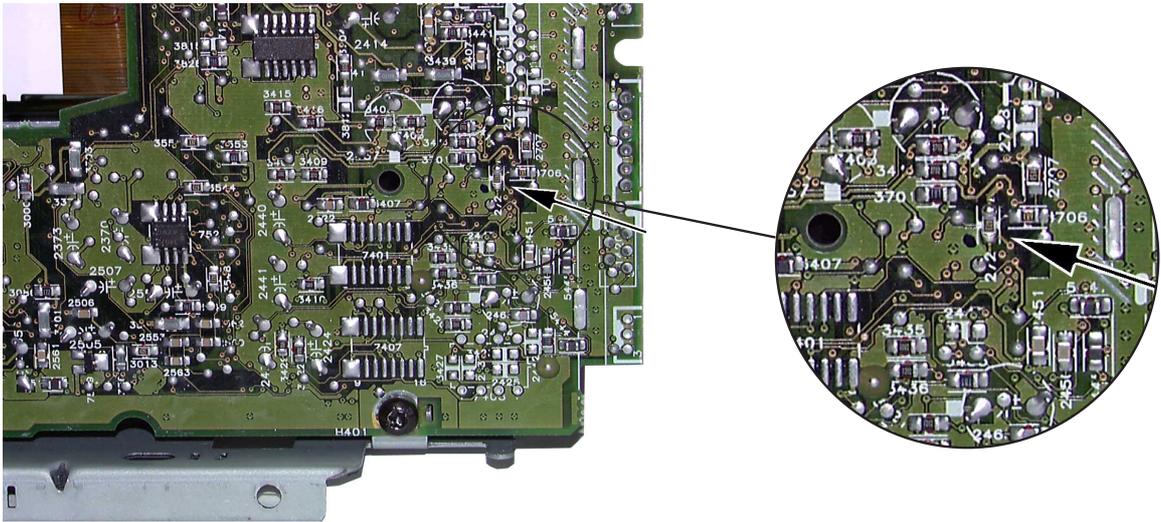
When source "AUX DIGITAL" is selected and no source is connected or it is switched off, there is a burst of noise audible through the speakers every 3 seconds. If a digital source is connected and switched on, the noise disappears.

- CURE :
- change SMD resistor
3300 on Interface Board (CDR785, CDR786) resp.
3358 on Digital Switch Board (FW-R7, FW-R8)
to 6.8k Ω (4822 117 11507)
 - add resistor 2721 (6.8k Ω 4822 117 11507) on the bottom side of CDR Main Board → see picture below

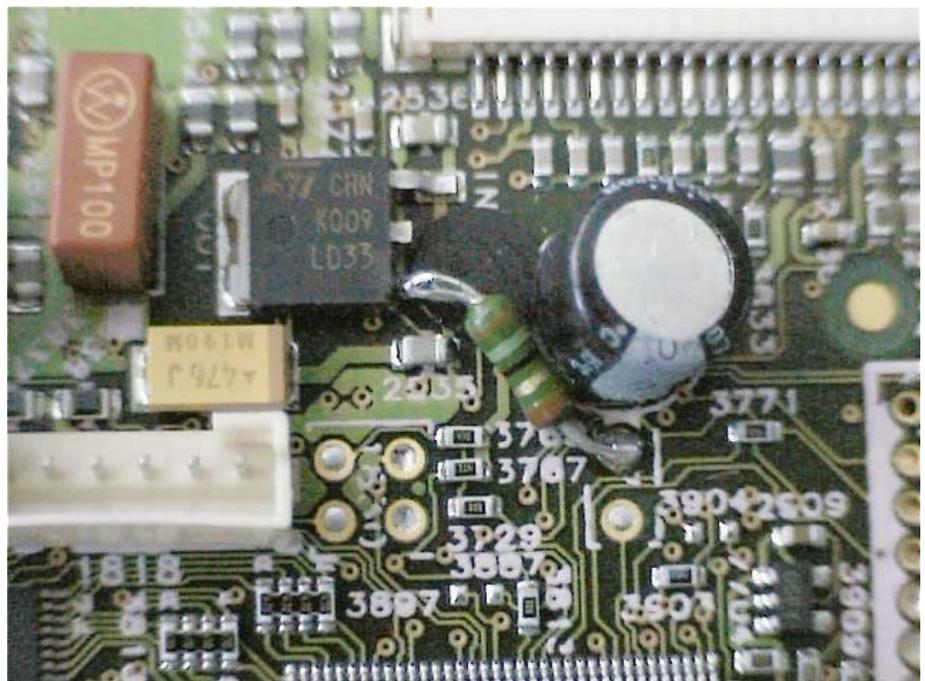
See part of the main board (top side view) for location of the resistor.

CURE : To solve this problem in running production and as service solution, the power supply of D3V3 has been improved by adding a resistor of 27Ω (CRB 1/6W A PM5 and ordernumber 4822 116 52188) between “disconnected” pin 1 of item 7535 and mass (hole 2 of item 1701).

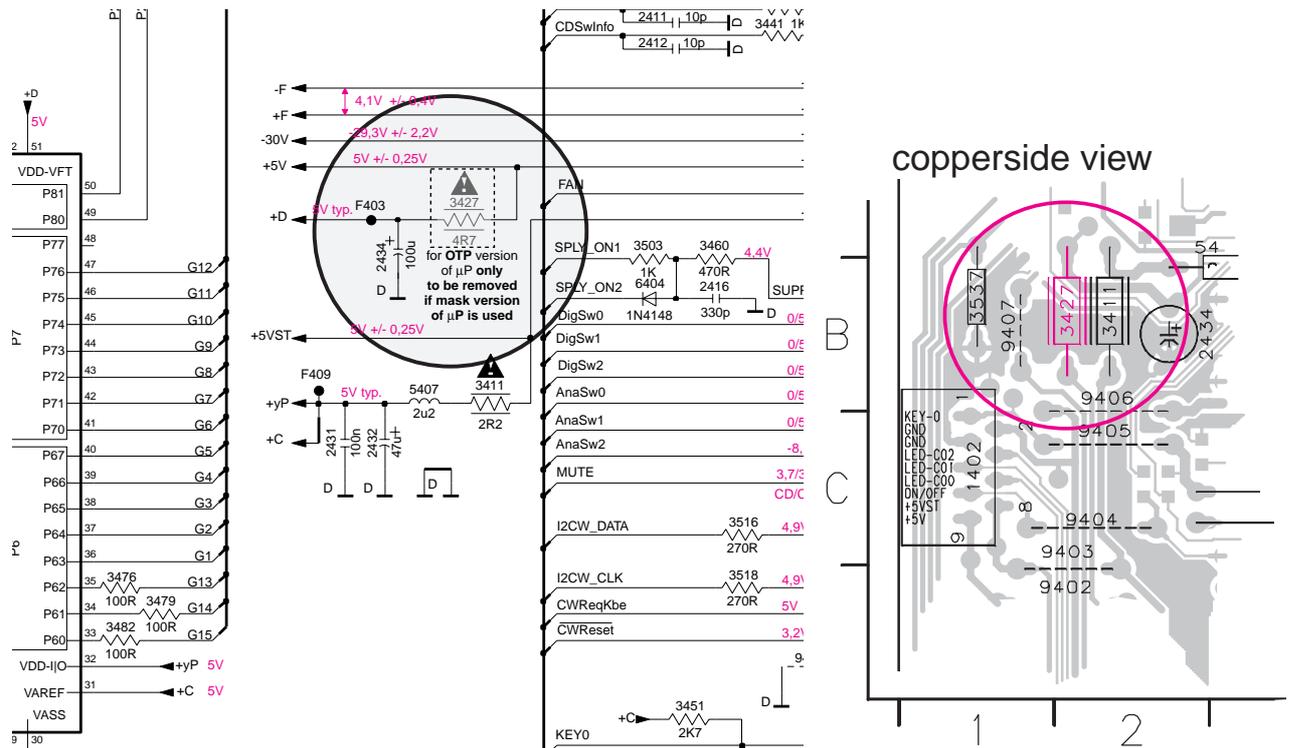
Reason: The mask version has an internal connection between the supply pins 32 (+µP) and 51 (+D).

In case an OTP-version has to be replaced by the mask version resistor 3427 has to be removed.

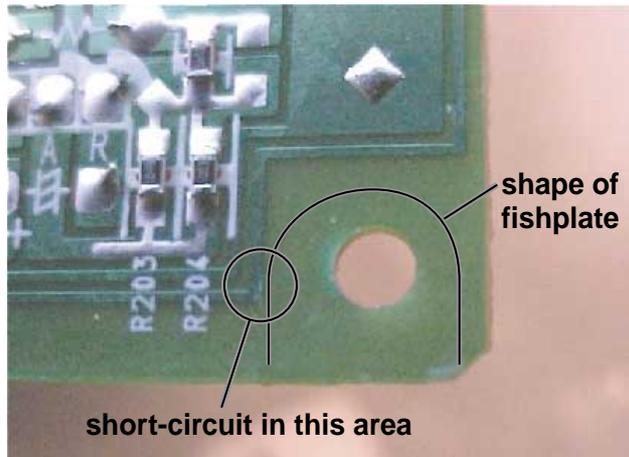
- SYMPTOM** : **IRIS CODE 1 1 1 X**
The Standby-LED is inoperative.
The power consumption in standby is higher than specified and close to the power consumption in STOP-mode.
- CURE** : The problem is caused by the fishplate supporting the Power Supply Unit. In some cases the fishplate can touch a copper track of the Power Board close to resistor R204 (see picture below).

This will short-circuit parts of the power supply circuitry to the ground potential of the bottom frame.
As a result, the display will switch off, but the LED does not light.

Solution: Place an insulating layer (i.e. friction tape or piece of Fuller board) between printed board and holder.

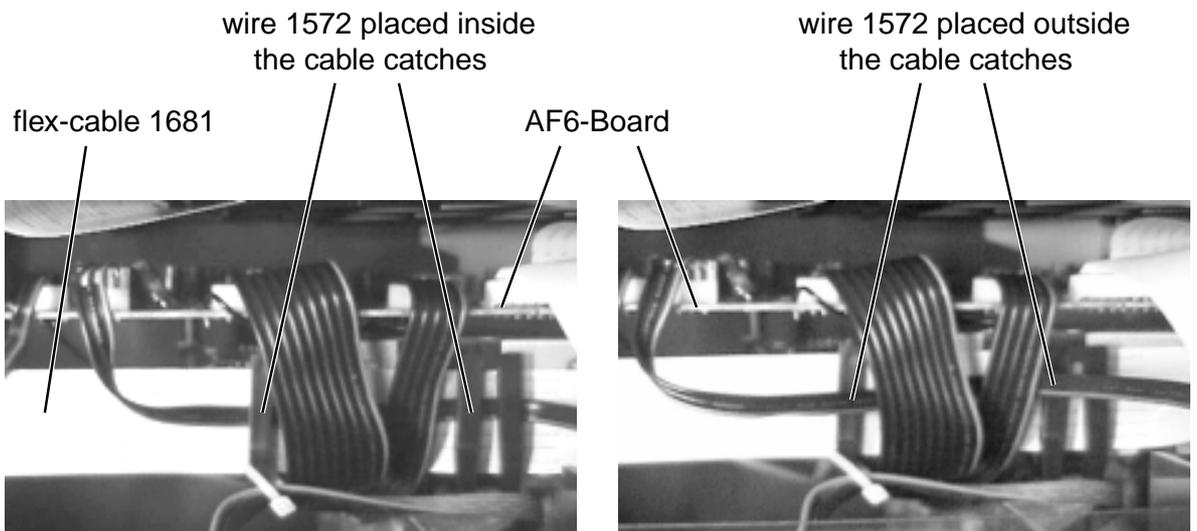
SYMPTOM : **IRIS CODE 1 5 4 4**
Ticking sound (similar to that of a clock) is audible from the center speaker during quiet portions of music.

CURE : The problem is caused by crosstalk from flex-cable 1681 to wire 1572.
The problem can be solved by routing wire 1572 outside the wire catches of flex-cable 1572 as shown in the right picture below.

fig.1 – wire position in a problem set

fig.2 – wire position in a good set

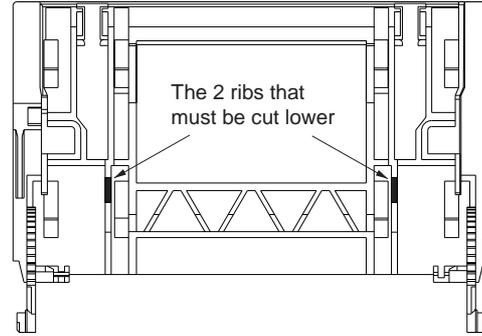
Figure 1. Portion of Problem Cassette Tape

CURE : The capstan pin (pos. 41) of the tape mechanism will not disengage fully from the cassette tape. The problem is caused by a combination of the following:

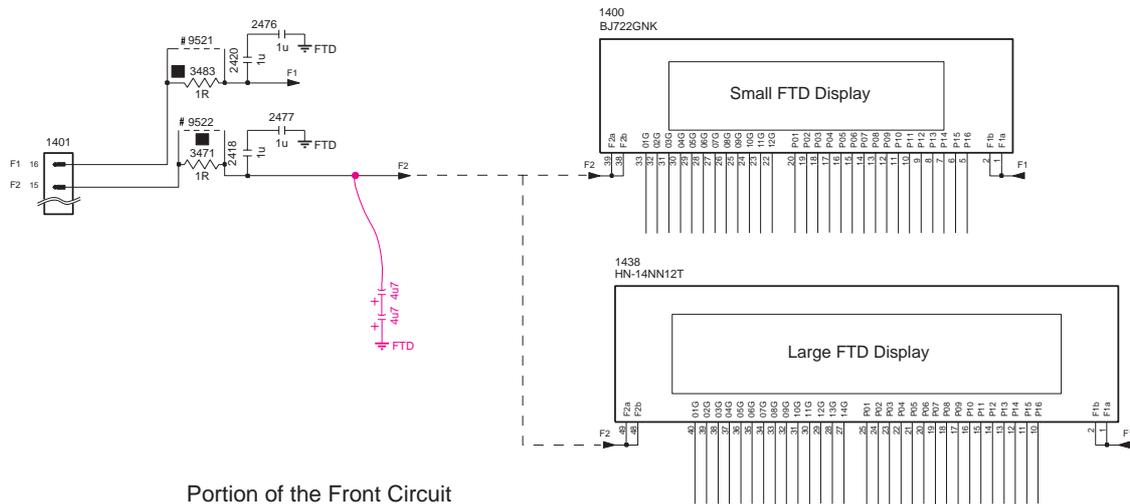
Portion of the Front Circuit

SYMPTOM : **IRIS CODE 1 1 4 X**
 A high frequency pitch (around 4kHz - 5kHz) is audible from the front display panel in quiet environment.

CURE : The source of the noise comes from the filtering SMD capacitors 2418, 2420, 2476 and 2477.
 The problem is resolved by adding 2 elcaps of 4,7 μ F (4822 124 40769) in series across the existing SMDs capacitors of the -F2 supply line.
 The elcaps can be soldered onto the copper side of the Front board as indicated in the circuit and SMD layout view below.

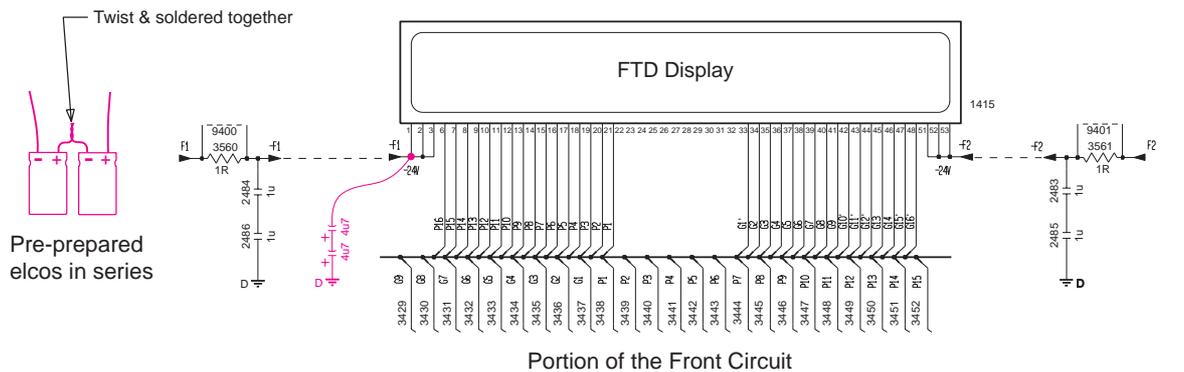
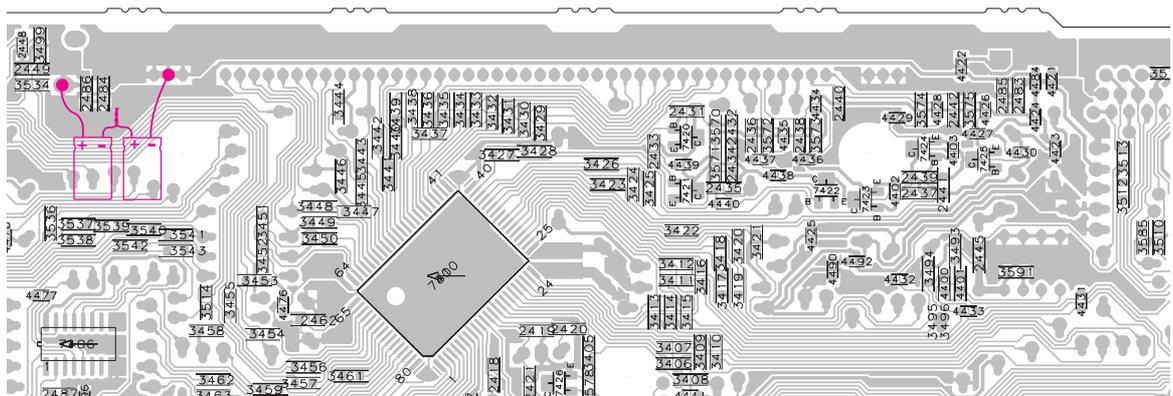
The problem is resolved by adding 2 elcaps of 4,7µF (4822 124 40769) in series across the existing SMDs capacitors of the -F1 supply line.

The elcaps can be soldered onto the copper side of the Front board as indicated in the circuit and SMD layout view below.

- 1) Dismantle the Rear Cover, Cover CDC and CDC Module.
- 2) Prepare the 2 elcaps of 4,7µF (4822 124 40769) in series.
- 3) Place an insulation tape onto the Front board (area under the elcaps) to prevent the elcaps and their leads from short-circuiting to the surrounding SMD components and pads.
- 4) Position the elcaps horizontally over the insulation tape and solder them to the copper pads as shown.
Make sure that the elcaps are close to the Front board so that there is no contact to the moving parts of the CDC module.
- 5) Re-assemble the CDC Module, Cover CDC and Rear Cover.

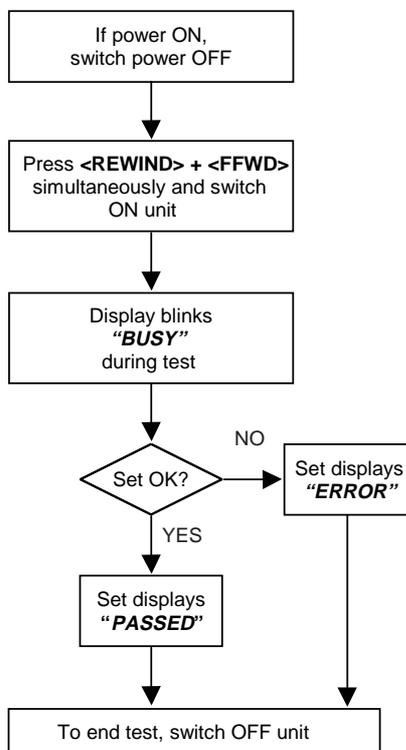
DEALER DIAGNOSTICS
(status of player)

INFORMATION : Correction to the Service Manual, Dealer Diagnostics Figure 6.1 is wrong. The correct buttons for entering the test are "REWIND" + "FFWD" (instead of "PLAY" + "STOP").

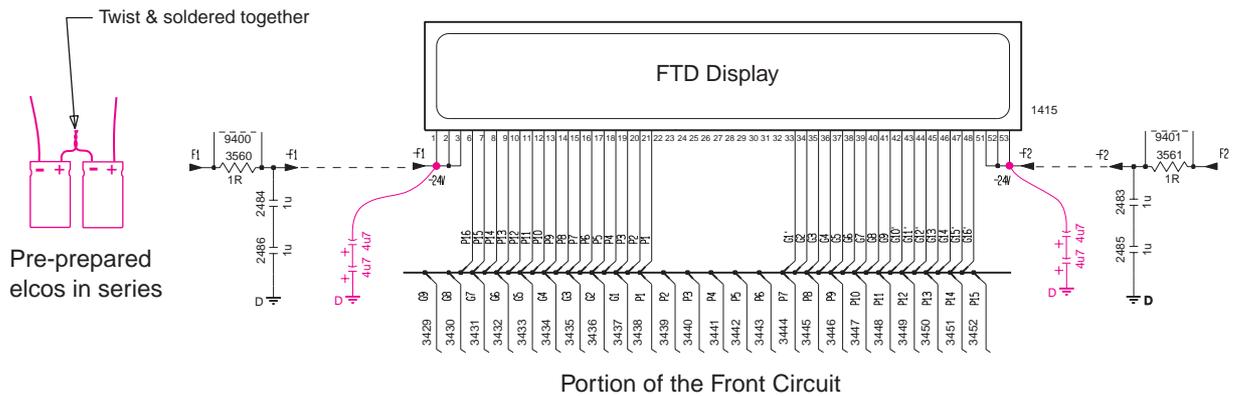
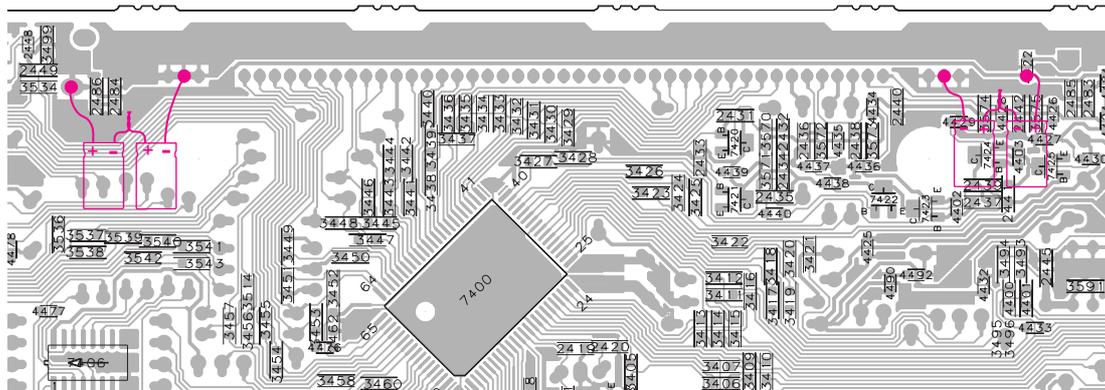
SYMPTOM : **IRIS CODE 1 1 4 X**
 Digital hum (whistling tone) is audible from the display in quiet environment.

CURE : The source of the noise comes from the filtering SMD capacitors 2483 - 2486 for the FTD display supply -F1 and -F2. The problem is resolved by adding 2 x 2 elcaps of 4,7 μ F (4822 124 40769) in series across the existing SMDs capacitors. The capacitors can be soldered onto the copper side of the Front board as indicated in the circuit and SMD layout view below.

- 1) Dismantle the Rear Cover, Cover CDC & CDC Module.
- 2) Prepare 2 sets of 2 x 4,7 μ F elcaps (4822 124 40769) in series.
- 3) Place an insulation tape onto the Front board (area under the elcaps) to prevent the elcaps and their leads from short-circuiting to the surrounding SMD components and pads.
- 4) Position the elcaps horizontally over the insulation tape and solder them to the copper pads as shown.
 Make sure that the elcaps are close to the Front board so that there is no contact to the moving parts of the CDC module.
- 5) Re-assemble the CDC Module, Cover CDC and Rear Cover.
