Published by:  
Service Department Audio

# SERVICE NEWSLETTER

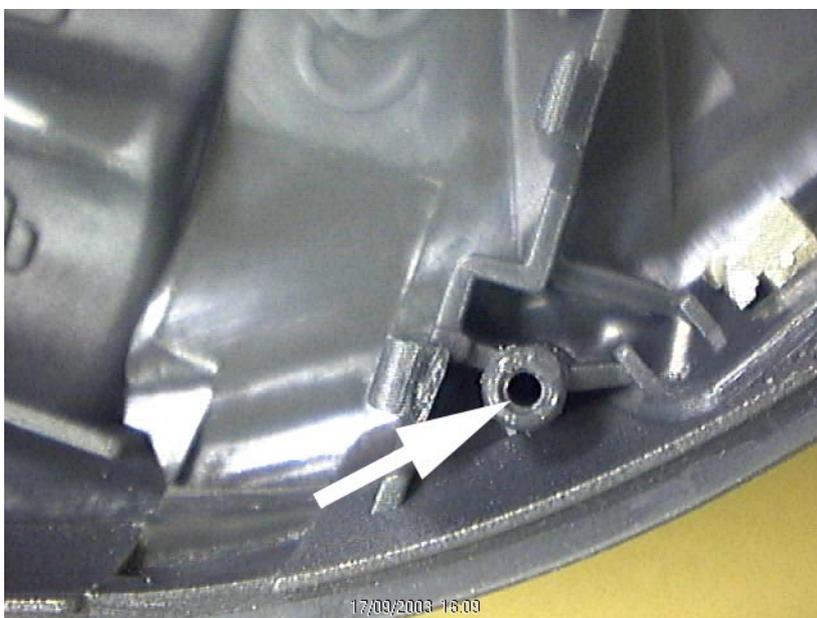
**INFORMATION** : In course of production a pole has been added to the Bottom Cabinet to strengthen the pcb supporting. If an old Bottom Cabinet needs to be replaced by a new one, we suggest to cut the pole as indicated in the drawing below:

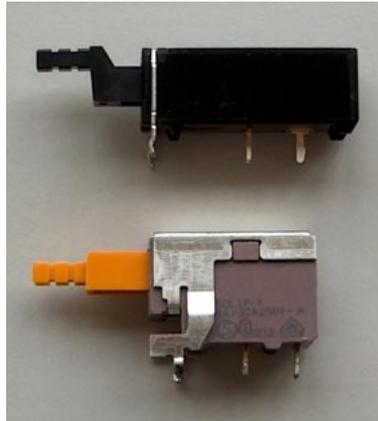
**INFORMATION** : In course of production the mains switch (item 1056) has been changed. New mains switches are used from mains board layout stage .4 onwards.

New switch  
1056 2422 128 03065 Mains switch

Old Switch  
1056 4822 276 13224 Mains switch

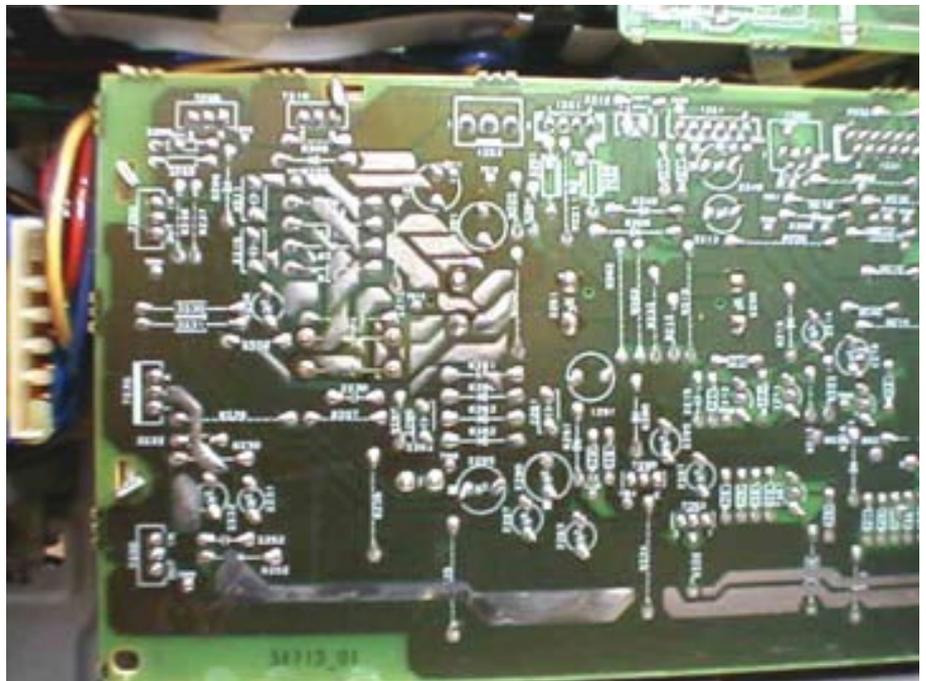
**SYMPTOM** : **IRIS CODE 1 1 6 L**

PC board turns brown from components 6250, 6251 and all over the area of 6210, 6211, 6212, 6213, 7250, 7230, 7260, 7295, 7210 on the Supply Board (pos. 1104-A). The area around the diodes 6250 and 6251 is the worst brown area on the PC board after few months of operating.

**CURE** : The PC board browning effect is caused by excessive heat generated by the supply regulators and the power devices.

There will be no short term solution as there are no safety or reliability issues. The operating temperature of the semiconductor junction is within the specification of the devices. The temperature of the PC board is also within the safety limits.

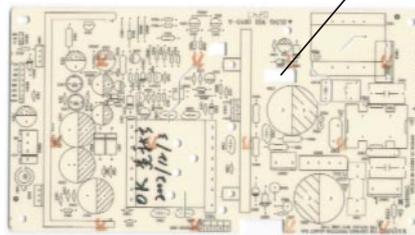
hole(s) added  
(Transformer is removed for clearer view)

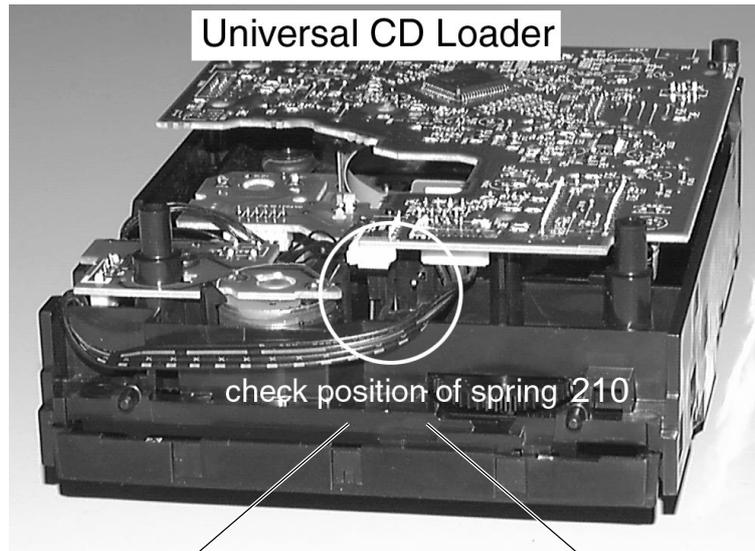
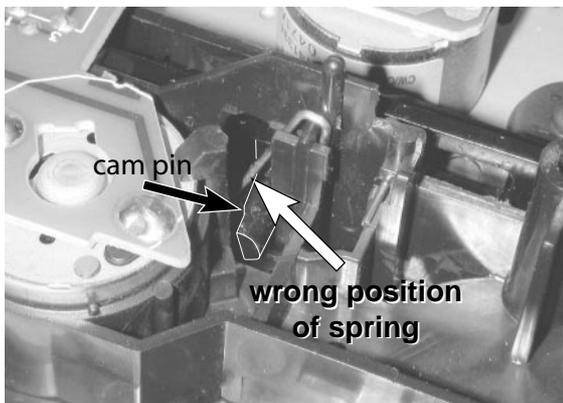
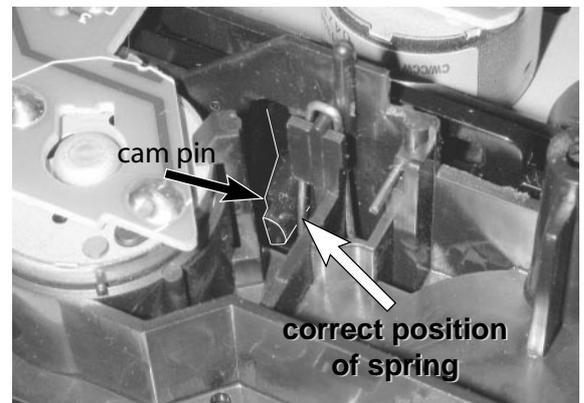
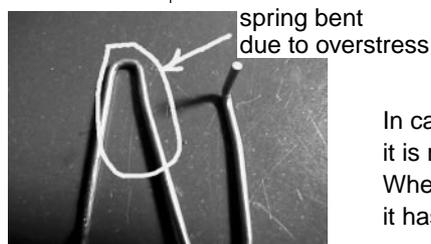
**SYMPTOM** : **IRIS CODE 1 6 2 6**  
CD tray does not open fully.

**CURE** : The problem is most probably caused by a wrong mounted spring 210. The spring is mounted on the wrong side of the cam pin protruding through the cabinet frame. For details see pictures below.

In case the spring has been found in the "wrong position", it is recommended to check it before re-aligning. When the spring is deformed as shown in the left picture, it has to be straightened before mounting it again.
