Published by:  
Service Department Portable Audio

## LINE OF BUSINESS PORTABLE AUDIO

# SERVICE NEWSLETTER

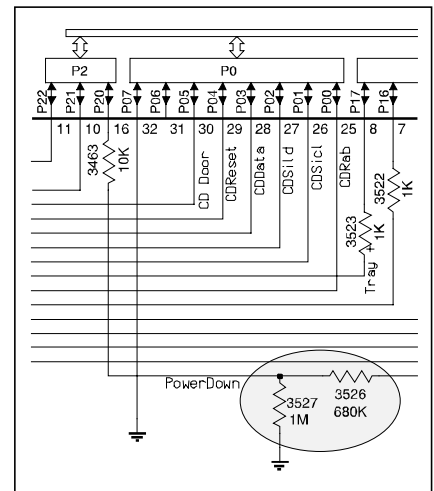
**INFORMATION :** Correction to the Service Manual, Frontboard:  
Following parts have been added/changed from production start onwards:

- Capacitor 2430 changed from 100pF to 470nF (4822 126 13482)
- Jumper 9440 replaced by resistor 3525, 47 $\Omega$  (4822 116 52195)
- Resistor 3526, 680k $\Omega$  (4822 051 20684) added
- Resistor 3527, 1M $\Omega$  (4822 051 20105) added
