Published by:  
Service Department Audio

# SERVICE NEWSLETTER

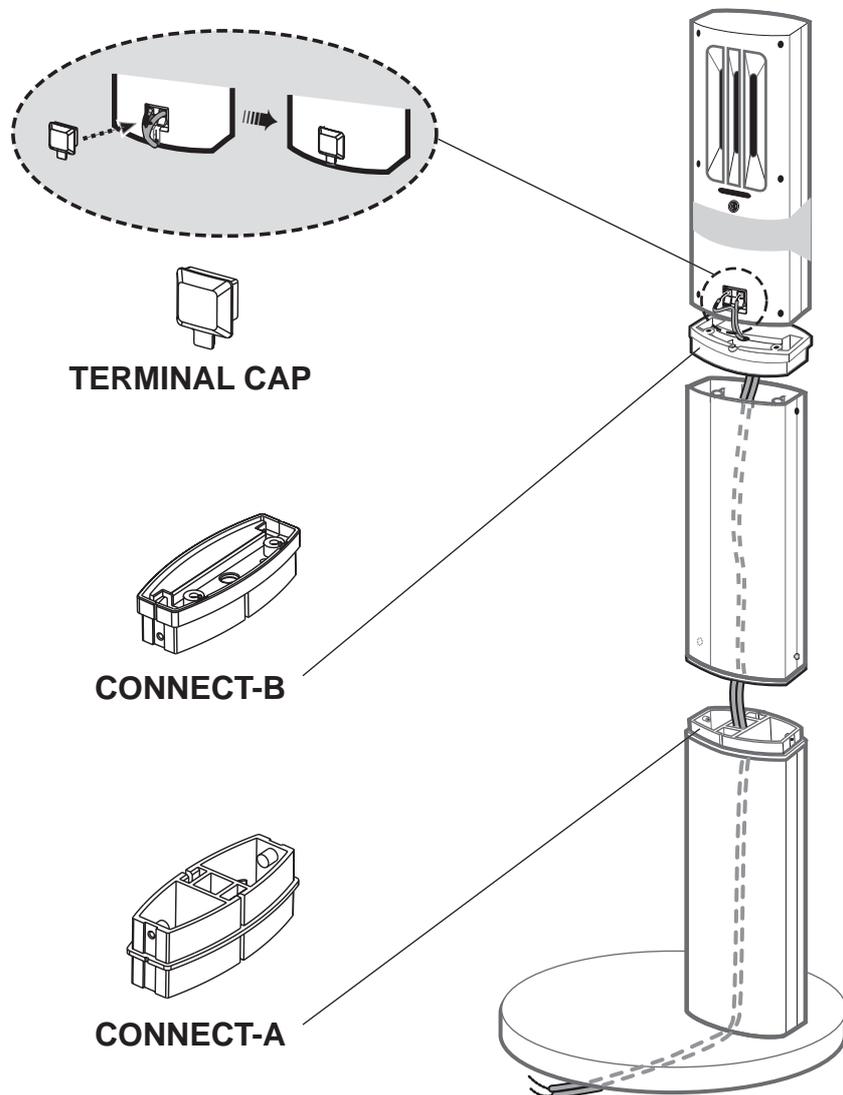
#### 06.11 TYPENUMBER(S): LX8000SA , LX8200SA

INFORMATION : LSBS8000 Speaker Stands (3139 118 79910)  
Following parts of the LSBS8000 are now available on service stock:  
9965 000 22306 CONNECT-A  
9965 000 22307 CONNECT-B  
9965 000 22374 TERMINAL CAP
